150 Year- Old Chapel Stabilized in Dayton, Ohio

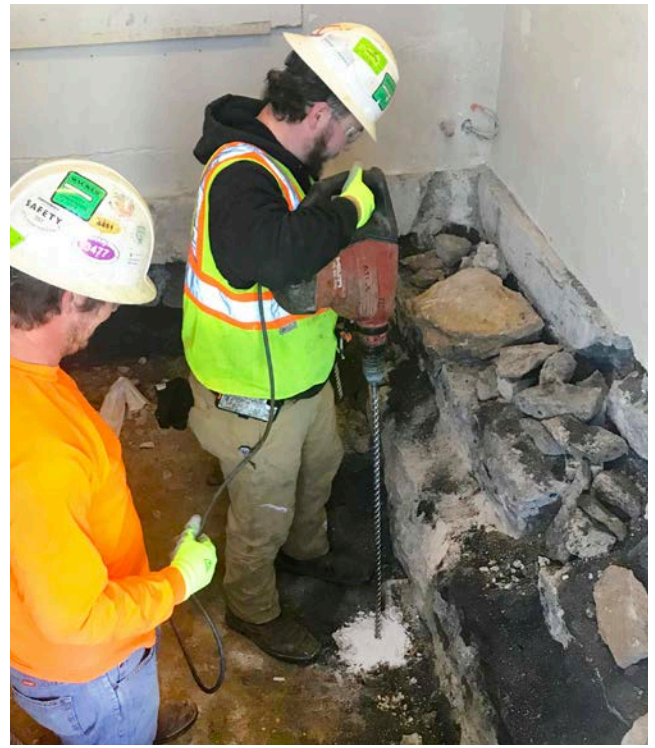
URETEK crew preparing for UDI

After consultation with project engineers and a review of all soil analyses conducted at the site, URETEK Deep Injection® (UDI) was agreed upon as the best solution for the site and the circumstances. URETEK crews arrived on site and quickly injected high-density polyurethane into the soils beneath the footings to mitigate the bell tower settlement issue.

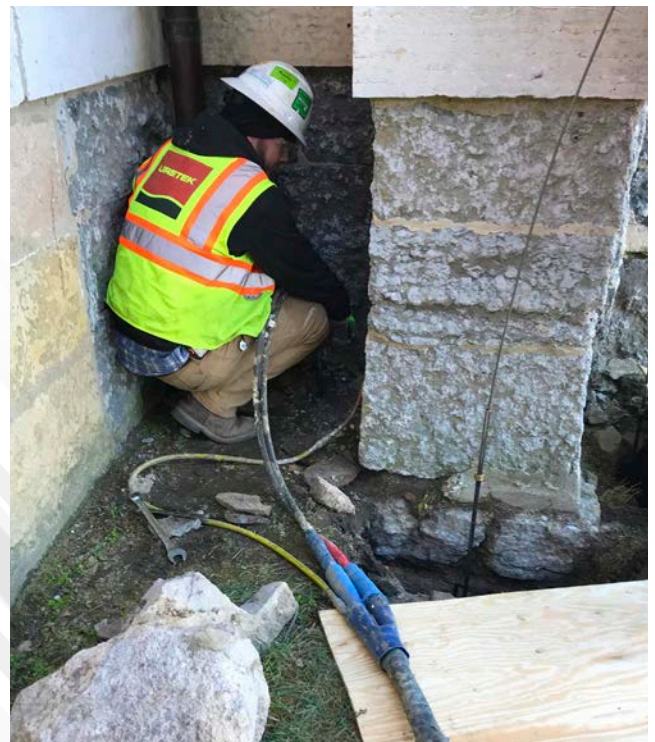
URETEK crews performed UDI at the base of the chapel's bell tower
