Storm Water Culvert Repair in Florida

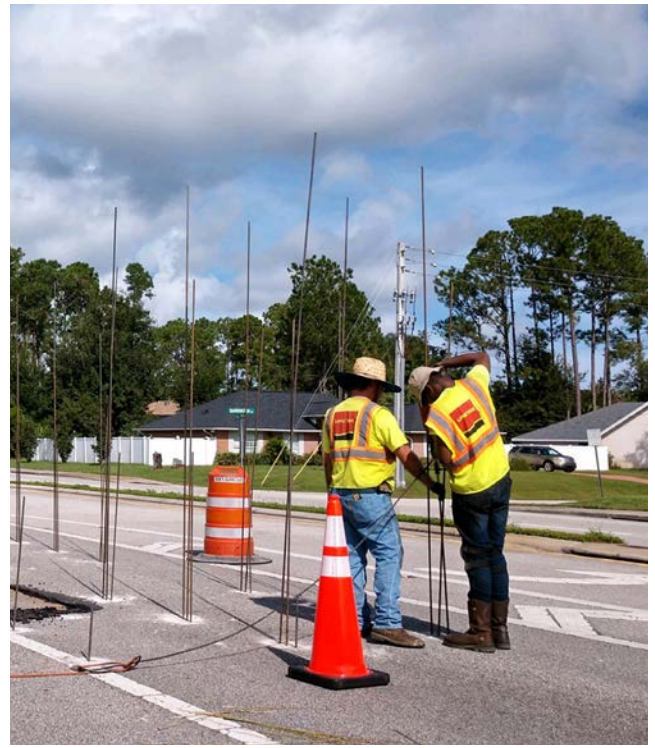
URETEK crew members install injection tubes at the work site

The injection plan involved two locations, extending in a wedge pattern out past the footprint of visible settlement, with the aim of tying stable soils to the area of weakened soils in proximity to the now-repaired storm water culvert. The first location involved three rows of injections: two rows on either side of the buried culvert to depths of four feet, eight feet, and 12 feet, and a final row of injections directly above the culvert to a uniform depth of four feet. At the second location, five rows of injections were required, with two rows on either side of the culvert – to

four, eight, and 12 feet – and a single row of injections above the culvert to a depth of four feet.
